# Timely remote support in lockdown situation saved ~\$37,000 for a supply vessel

<b>INDUSTRY SEGMENT:</b>	Marine
<b>CUSTOMER:</b>	Triton Logistics & Maritime - fleet operator of supply vessels for drilling and marine support services
<b>EQUIPMENT:</b>	Vessel tug boat
<b>ARM SOLUTION:</b>	Caterpillar make C18 Engine

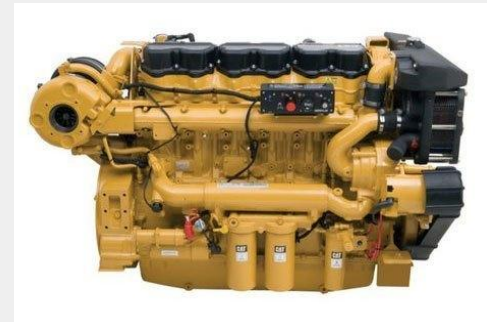
- On 20th May 2020, the chief engineer of the vessel sent a **SOS email** to Neptunus **for resolving a critical problem on the auxiliary engine** of the subject vessel. The engine was frequently tripping & the vessel engineering team could not fix it onboard.
- Though this was an auxiliary engine, for operation of Bow Thruster (BT), it was necessary to have this engine in proper running condition, else the **vessel could have been de-hired leading to substantial loss.**
- Due to lockdown** situation, Neptunus' service team was **unable to travel to attend to this problem**

*"Appreciate your quick response and suggestions. I would like to inform you that the problem has been traced by the ship staff and rectified. The rotating rectifier assembly cables were found partially damaged because the rectifier plate holding bolts were in loose condition. Other checks on the engine were satisfactory."*

- Neptunus has been a **preferred partner** to Triton for engine maintenance across their multiple vessels
- Neptunus' service team assessed the situation, **studied the symptoms** after discussions with the vessel engineering team and **quickly made a "checklist" to trace the possible root-cause.**
- Accordingly following was checked by the vessel engineering team
  - After restarting the engine what is voltage value?
  - Had they flashed the Exciter?
  - What is the winding resistance & insulation value?
  - Have they done the visual Inspection of the rotating rectifier assembly?
- Within 12 hours** of first reporting the problem, **the root cause was found** in the loose bolts of the rotating rectifier assembly & problem was resolved soon after. The **engine started running smoothly** without tripping.
